# Summary of key points from Broadclyst accessibility audit Date: 14 May 2026

**Context:** The Parish Council requested a review of key pedestrian routes within the village – in particular, links between the supported living bungalows around Broad View and key facilities including bus stop.

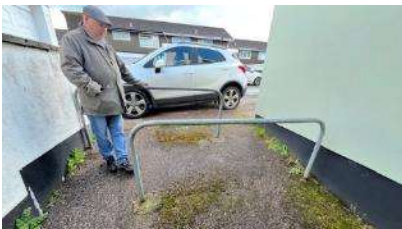
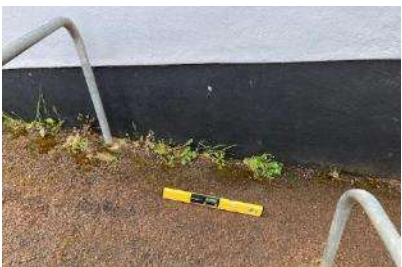
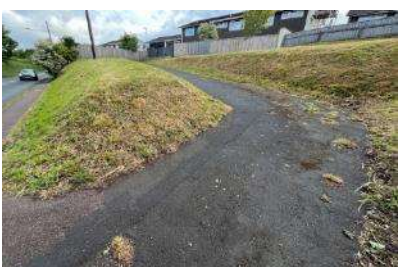
## Route 1

The most direct route to the main road/ bus stops, using a series of walkways between houses. However, the walkways have chicanes installed which provide insufficient space for mobility equipment to easily pass around. Gaps are 80 – 100 cm compared to the recommended 120 - 150cm. This is compounded by the short but steep slopes – often beyond the 15% that tends to be the maximum up/ down gradient for standard mobility scooters. In many cases the user would need to be crossing this gradient which has a particularly high risk of tipping. It also compounded by the limited spacing **between** barriers – difficult for longer mobility equipment to pass through. Finally, the route brings you to two bus stops which are difficult to use – particularly the northbound stop where there is insufficient space to get onto a bus ramp.

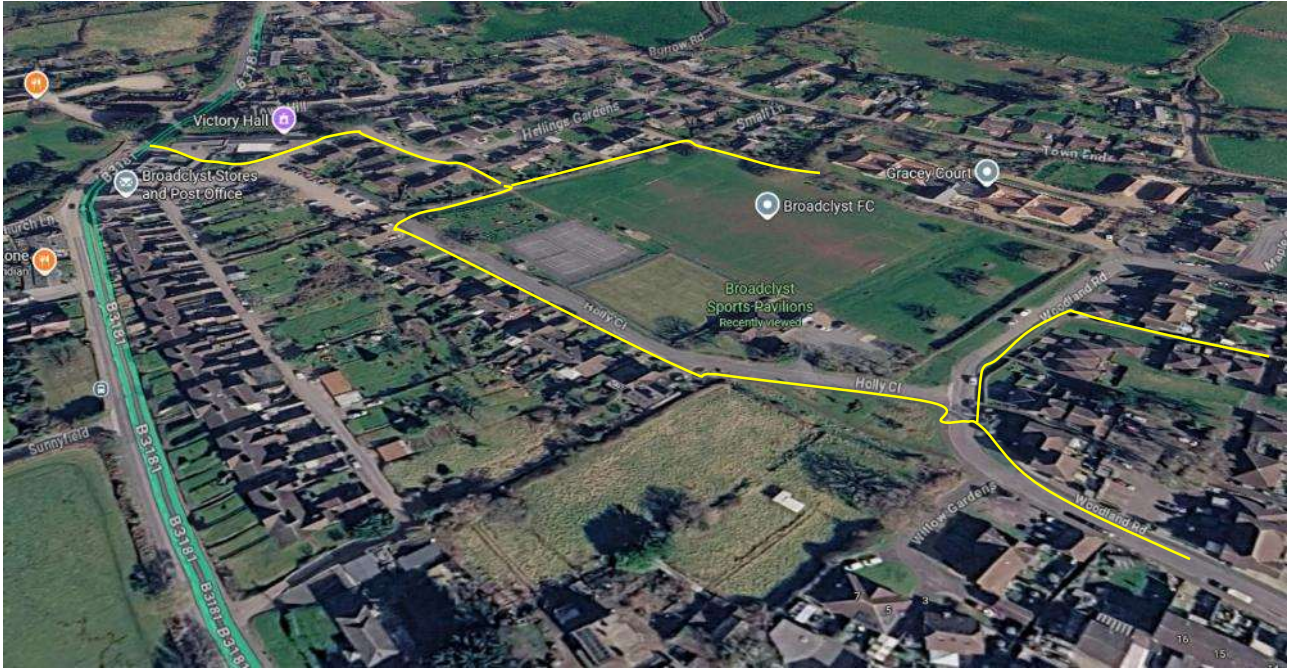
## Route 2

Although a longer route this is easier and takes you to the key village services and bus stops which are more suitable for mobility equipment. It also provides an option for residents at Gracey Court. The dropped kerb near the Holly Close/ Woodland Road junction is steep so requires care. At the end of Holly Road a path leads down but access to this

path is currently difficult due to a lip on the dropped kerb and then a 25% ramp up to the path. This would most easily be addressed by opening up the corner and taking back the barrier (see photo).

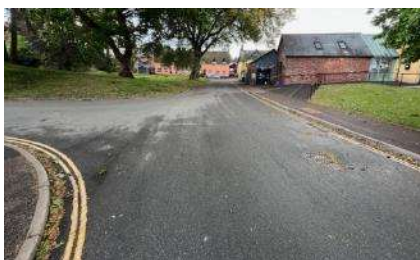
At the junction of Hellings Road it would be helpful to add dropped kerbs on opposite sides of the road to allow easier crossing to/ from Broadclyst Surgery as this is one of the key facilities.

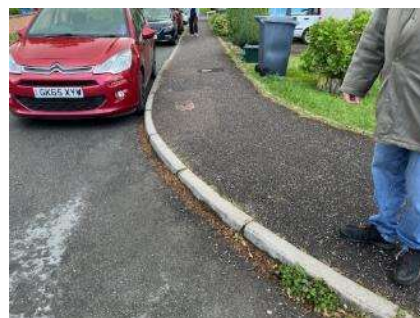
The route to other facilities would then head left (west) towards the public car park. However, it was noted that the dropped kerb is generally blocked by the car space being occupied. This space either needs to be marked out to remain clear or on the preceding corner (shown on the photo) a dropped kerb could be installed.

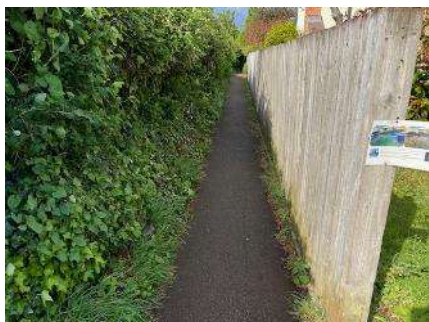
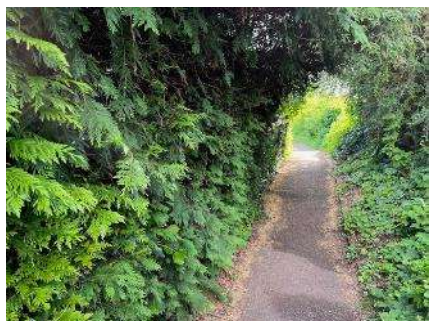
## Route 3

The final option reviewed was a narrow path cutting through from Holly Close. Although narrow it is currently sufficient width for mobility equipment to use, helped by being straight and has no barriers. However, there is a reliance on vegetation on side remaining cutback to maintain the width. There is very steep slope (22%) at one point but this only lasts for 2 – 3 metres and therefore is likely to be manageable for most users and equipment apart from a self propelled wheelchair. Adding a handrail would be helpful.

The second half of the path (where the slope is) has a lot of vegetation blocking light which will make this a dark path to use in the autumn/ winter. The addition of lighting – at the slope – and, ideally, in a couple of other locations along the path will therefore help to provide the security and confidence for it to be used.

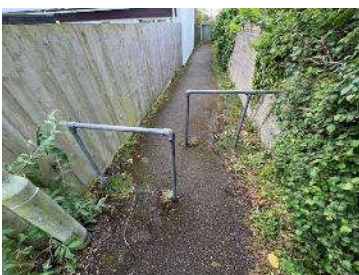
**A route leading to the south of the village** was also reviewed. This used Route 1 (with its many problems) and then uses a pedestrian cut through to Old Coach Road. This has a chicane at both ends – with same challenges of fitting mobility equipment through but at least on a relatively flat surface.

Immediately after the chicane by the exit onto Old Coach Road there is a steep slope (19%) leading directly into the road.

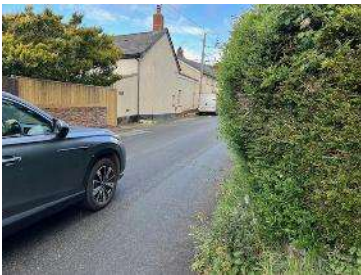
There is no pavement to turn onto and visibility to the right is extremely restricted due to the hedge. This makes it very dangerous for a person with less mobility to proceed on safely – particularly to the north.

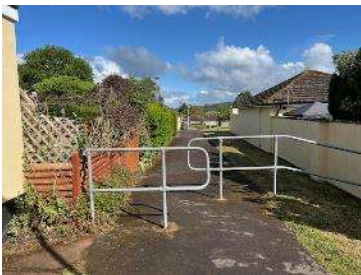
A final element that was considered was the access to **Broad View** itself. Chicanes have been installed on many of the exits/ entrance paths which now makes it difficult for residents with mobility equipment.

If the purpose is to prevent vehicles this could be achieved by removing one of the two barriers which would at least make passing through easier. It is recognised that it would make it easier for bikes and motorbikes to pass through but for the former there would not be any particular difference.

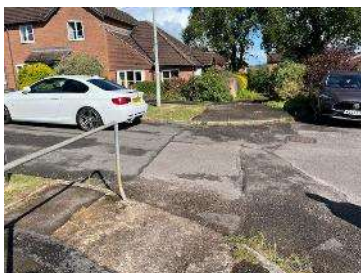
A lack of design consistency was also observed with the most striking example being the provision of a handrail – despite minimal gradient – to a dropped kerb but there then being no dropped kerb on the opposite side.
